**NASA Contractor Report 180809**

**EVALUATION OF COATED COLUMBIUM TEST  
PANELS HAVING APPLICATION TO A  
SECONDARY NOZZLE EXTENSION FOR THE  
RL10 ROCKET ENGINE SYSTEM; PARTS I  
AND II**

**FINAL REPORT**

*Pratt & Whitney  
Government Engine Business  
P.O. Box 109600  
West Palm Beach, Florida 33410-9600*

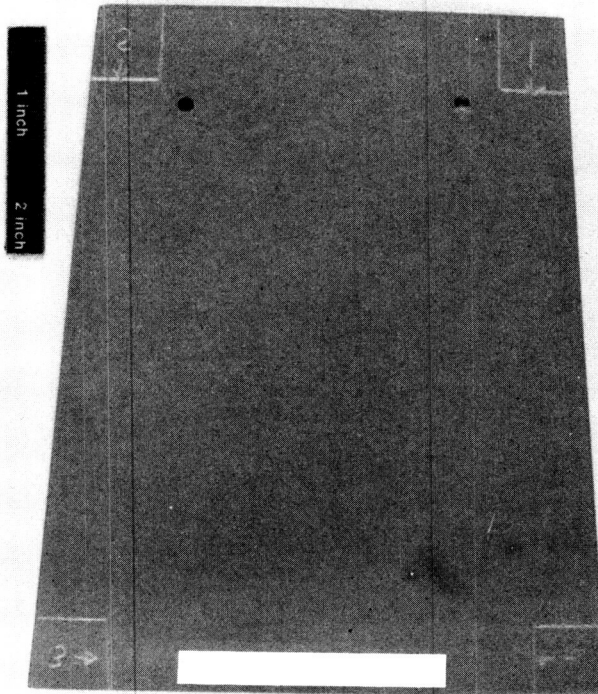
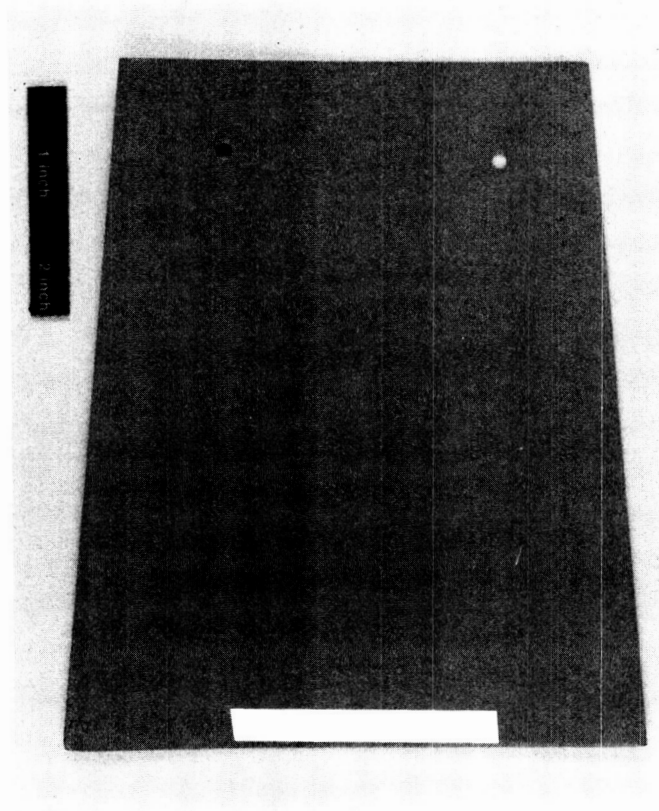
Hitemco has extensive experience coating C-103 material with R512-E (Si-20Cr-20Fe). This coating/substrate combination is presently used in parts for the augmentor of the P&W F100 jet engine. No visually obvious surface flaws were detected on the as-received panels (Figures 2-3 and 2-4). Metallographic examination showed that the nominal  $3.0 \pm 1.0$ -mil goal was achieved with approximately 1.0 mil of interdiffusion. Coating and substrate thicknesses averaged  $3.1 \pm 0.5$  and  $14.9 \pm 1.7$  mils respectively (Figure 2-5). The microstructure was typical for R512-E (Figure 2-6). Through-thickness cracks were present, but are common in the typical R512-E microstructure. These cracks are usually attributed to metallographic preparation. Microprobe results were typical of R512-E. The backscattered image (BSI) and elemental maps illustrated the interaction of the coating elements (Si, Cr, and Fe) with the substrate elements (Cb, Hf, and Ti) (Figure 2-7).

*Figure 2-3. Side 1 of Hitemco R512-E (Flame Side)*

*Figure 2-4. Side 2 of Hitemco R512-E*

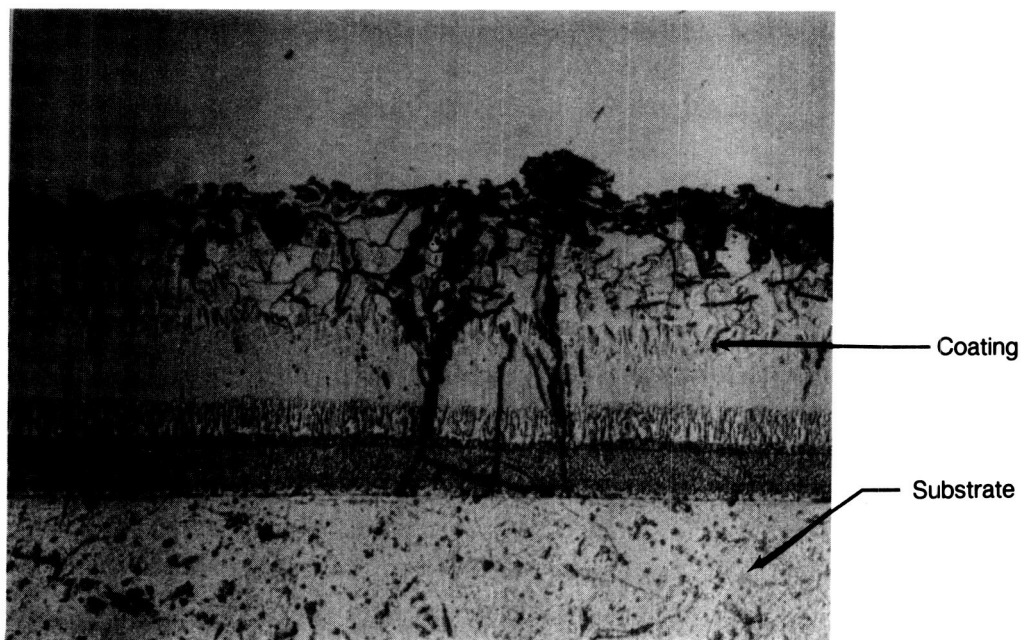
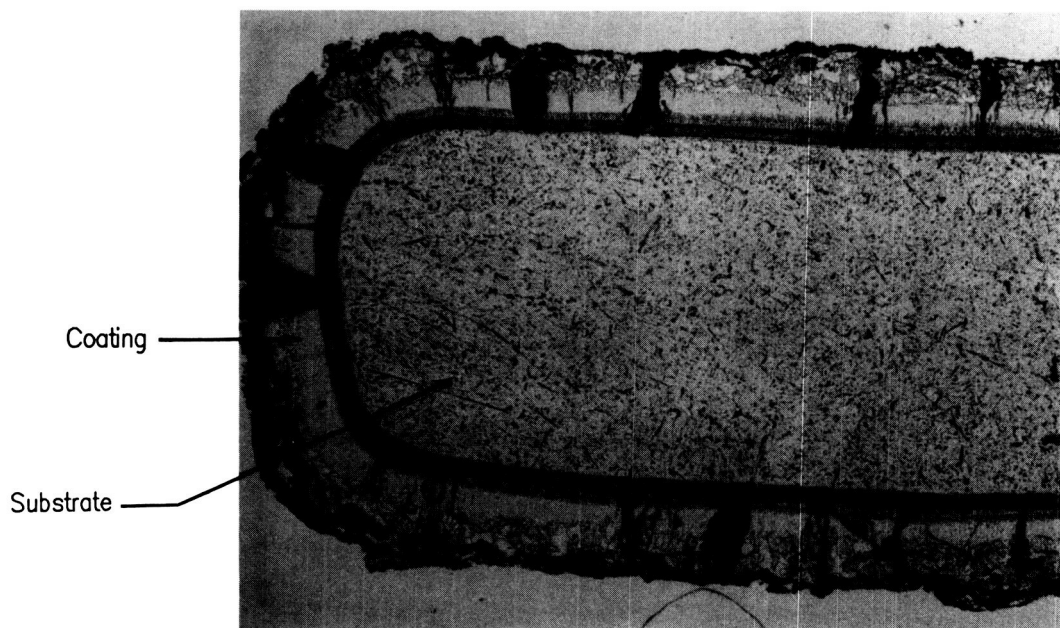
Figure 2-6. Hitemco R512-E Microstructure (Etch: 60% Lactic; 20%  $\text{HNO}_3$ ; 20%  $\text{Hf}$ ;  
Thickness:  $3.1 \pm 0.5$  mils)

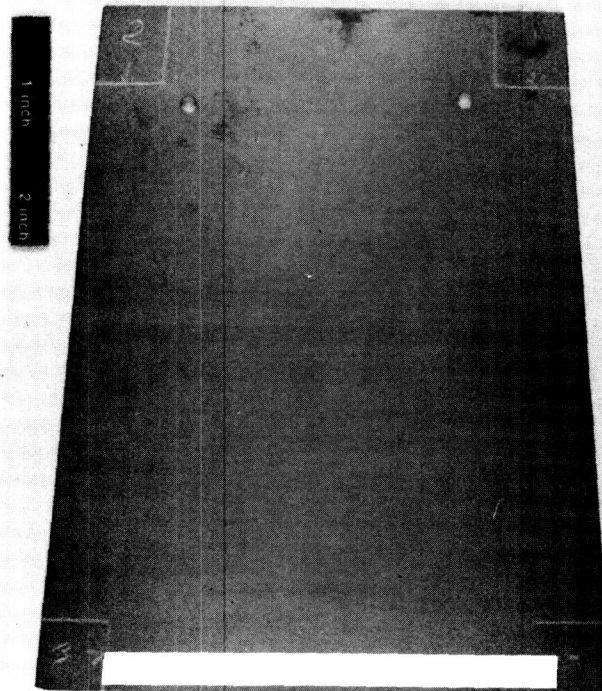
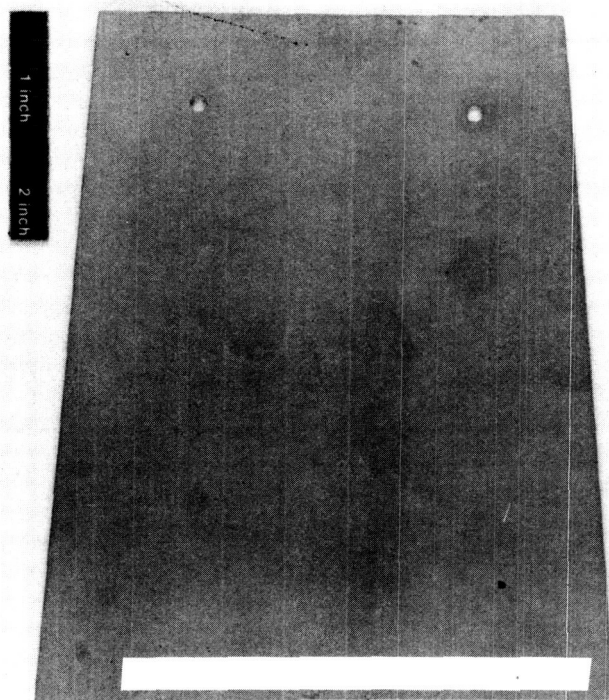
Chromalloy has acquired a CVD system capable of coating RL10 nozzle extensions. The general appearance of the coated panels was good (Figure 2-8 and 2-9). The coating appeared to be uniformly applied to all regions of the panel. Metallographic documentation of the coating and substrate thicknesses are illustrated in Figure 2-10. The coating thickness averaged  $1.4 \pm 0.2$  mils, which is much thinner than the target thickness of 3.0 mils. Chromalloy speculates that as Si is deposited and reacts with Cb, the resultant CbSi phase retards further reaction, thus limiting the coating thickness that can be attained in a reasonable time frame. The substrate thickness was very consistent at 15.5 mils. Chromalloy indicates that the coating is

*Figure 2-8. Side 1 of Chromalloy W3-Mod. CVD Si (Flame Side)*

*Figure 2-9. Side 2 of Chromalloy W3-Mod. CVD Si*

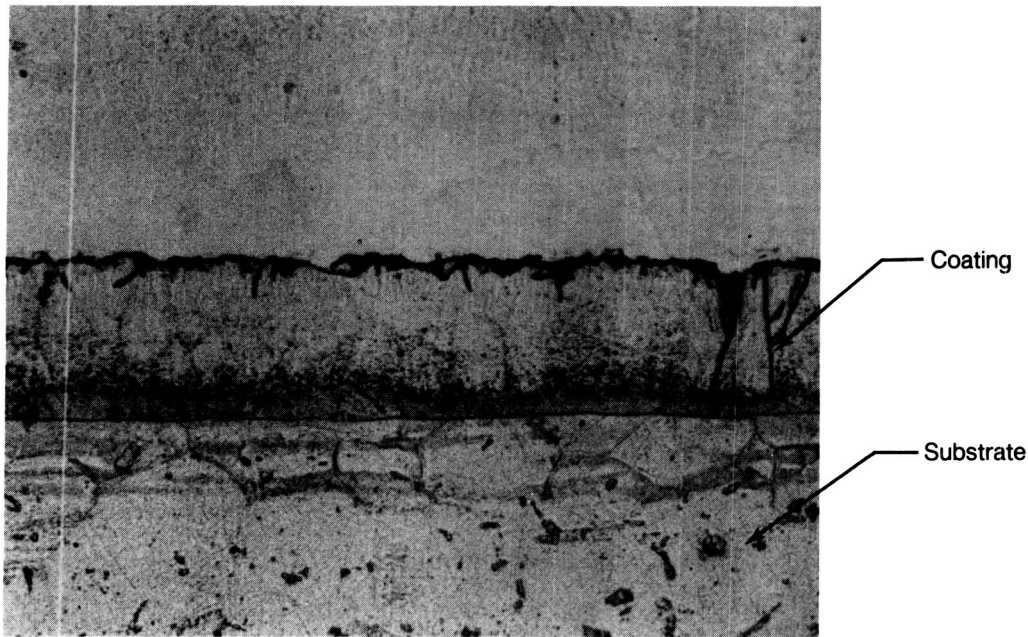
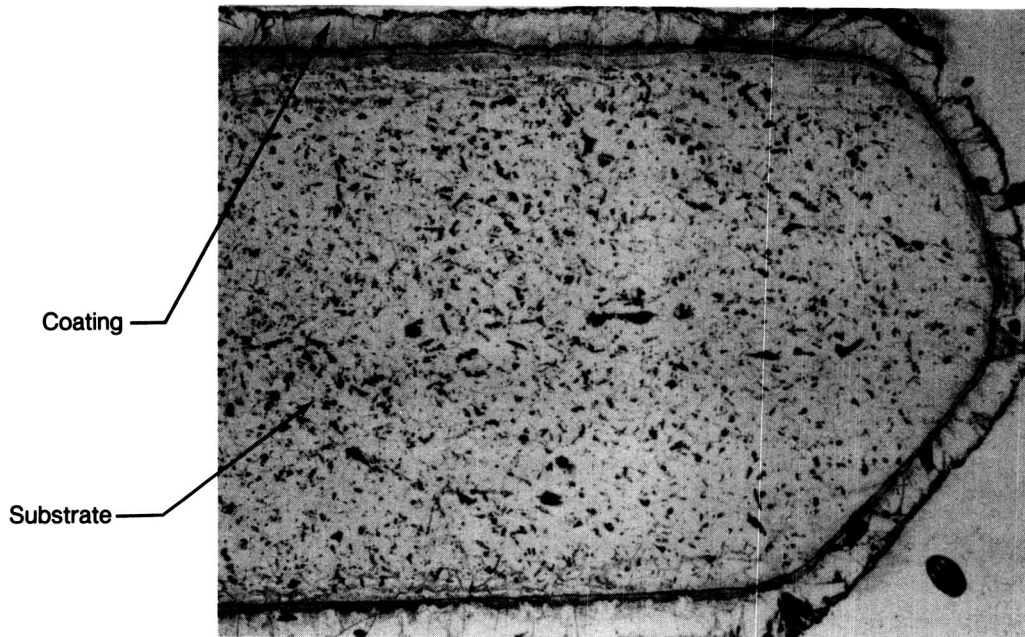
more of a buildup type than an interdiffusion type; therefore, limited or no substrate conversion to coating would be expected. The microstructure was consistent with occasional through-thickness cracks (Figure 2-11). These cracks were attributed to metallographic preparation. Characteristic x-ray elemental maps identified the presence of substrate elements (Cb, Hf and Ti) in addition to Si in the coating (Figure 2-12).

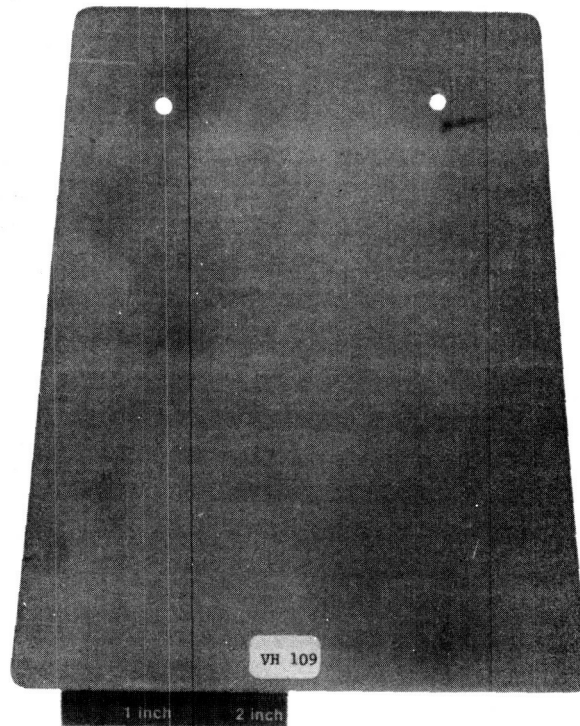
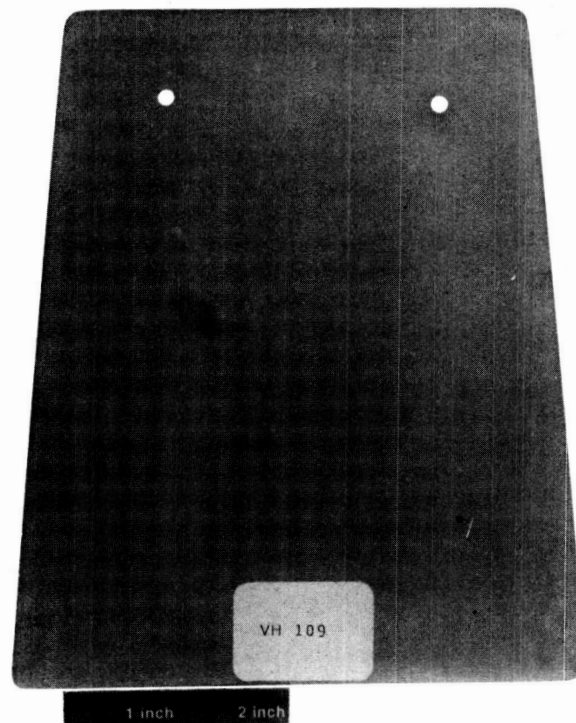
The general appearance of the VH-109 coating was good. However, minor discolorations and surface roughness variations were evident in the vicinity of the panel edges (Figures 2-13 and 2-14). The average coating thickness,  $4.1 \pm 0.4$  mils, was slightly thicker than the target thickness of  $3.0 \pm 1.0$  mils (Figure 2-15). This small thickness variation should not affect the coating performance. The substrate thickness is 4.5 mils below the original 15-mil-thick sheet. However, variations in sheet thickness combined with 1.0 mil of interdiffusion per panel face could result in 10 mils of substrate after coating. The typical microstructure had through-thickness cracks (probably induced by metallography), and a phase at the coating midplane that was intermittently present (Figure 2-16). Also, a significantly thick oxide layer had formed on the coating. Microprobe analysis resolved the intermittent precipitates as Hf- and Cr-rich (Figure 2-17). These elements were also present in the apparent interdiffusion zone. Observations from the x-ray maps indicated that the oxide was Hf-rich with Si and Cb.

*Figure 2-13. Side 1 of Vac Hyd VH-109 Coated Sample (Flame Side)*

*Figure 2-14. Side 2 of Vac Hyd VH-109 Coated Sample*

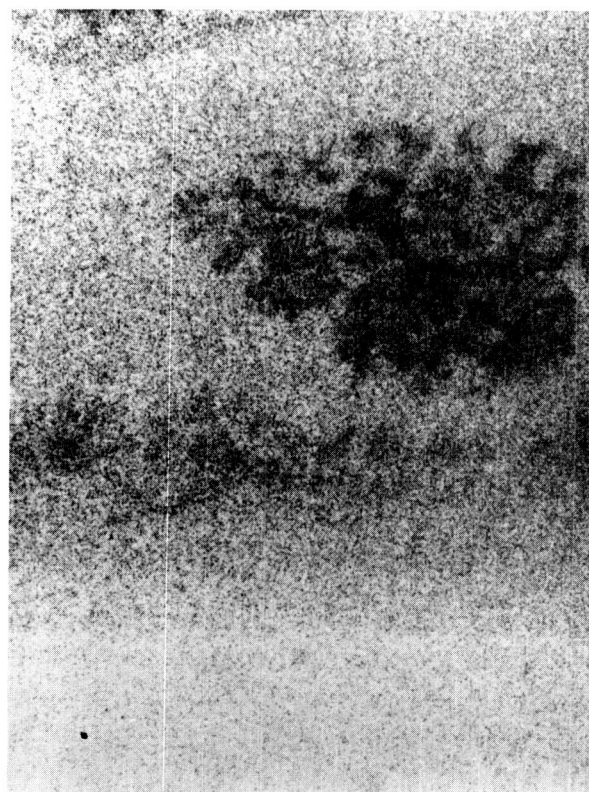
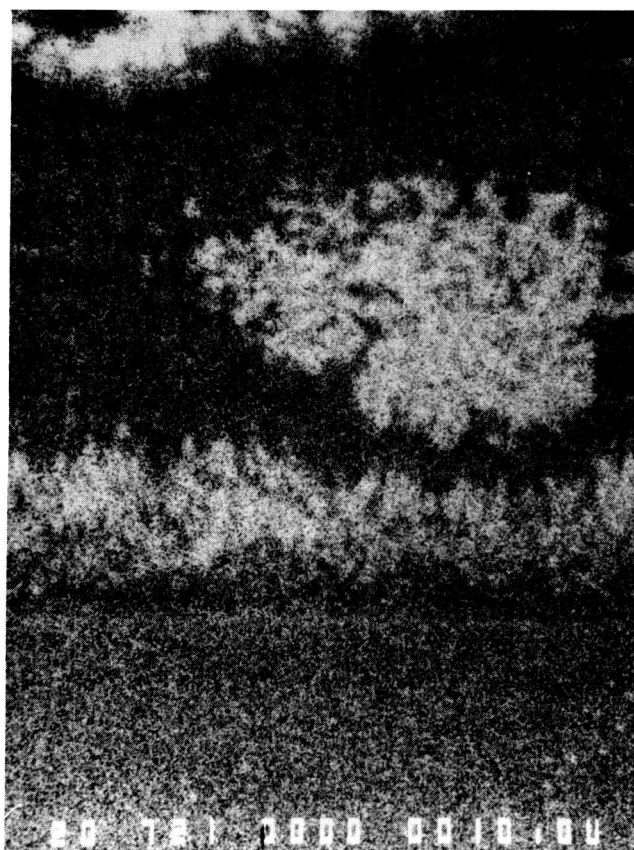
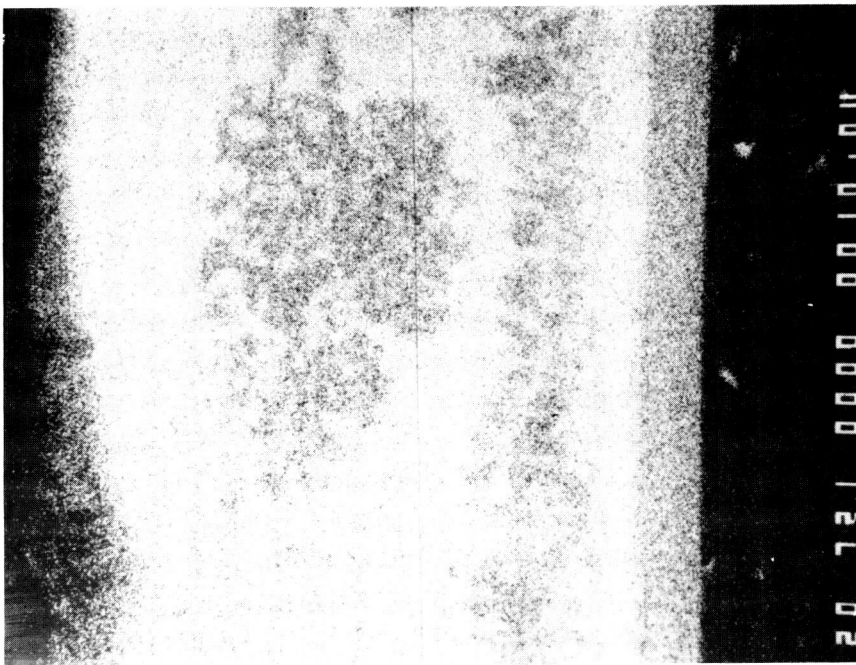
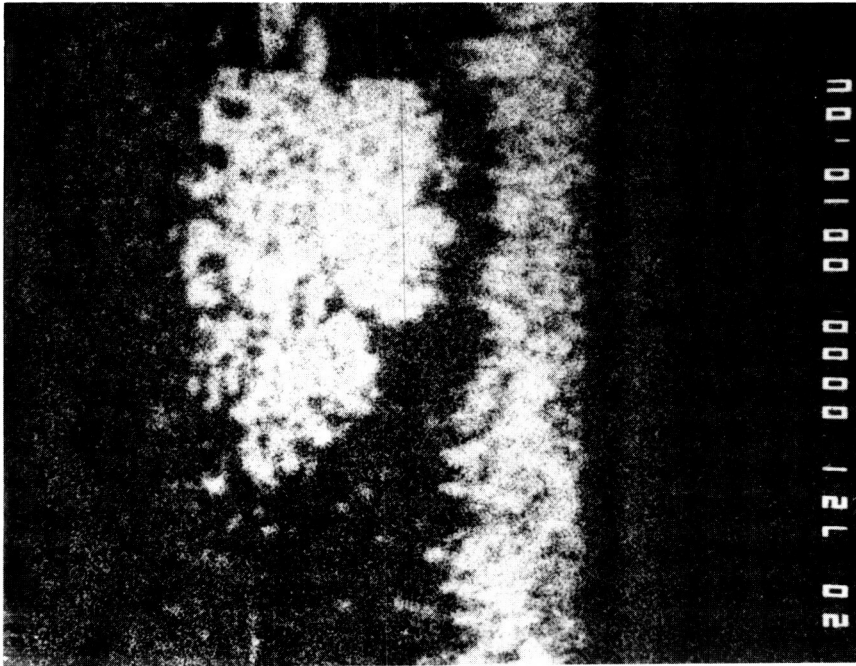
Figure 2-17. Elemental X-ray Maps of Vac Hyd VH-109 (Sheet 1 of 2)

Figure 2-17. Elemental X-ray Maps of Vac Hyd VH-109 (Sheet 2 of 2)

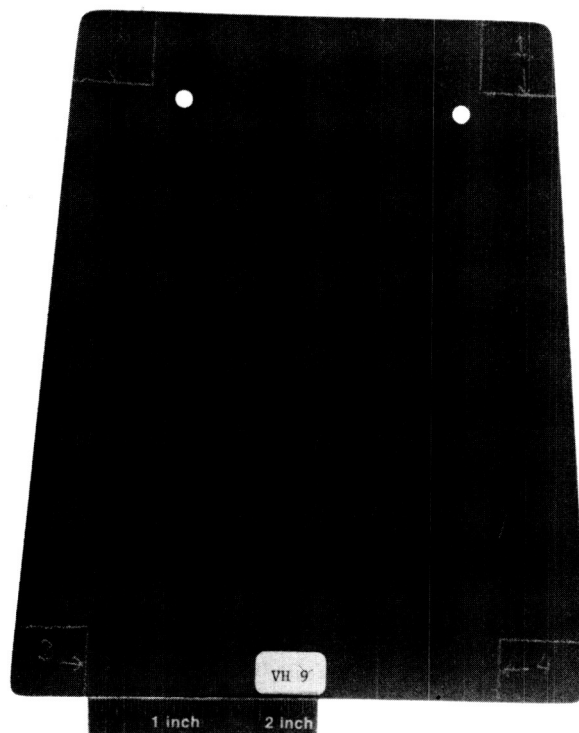
The as-received VH-9 panel was dark gray with many surface protuberances near the panel edges (Figures 2-18 and 2-19). The panel was visually thinner than uncoated panels, and metallography confirmed this observation (Figures 2-20 and 2-21). The coating thickness was inconsistent, ranging between 7.0 mils at protuberances to 1.5 mils in other locations. The substrate thickness was thin, ranging from 7.0 to 9.5 mils. No logical explanation for the large deviation from the original 15-mil panel thickness can be determined. The microstructures in Figure 2-21 readily depict the inconsistent nature of this coating/substrate system. Microprobe analysis showed the coating was layered (Figure 2-22). The outer region was rich in Si with some Cr. The apparent interdiffusion zone was rich in Al. Locally high concentrations of Si, Cr, Ti, Hf and Al were present throughout the coating. The detection of Si and Cr was unexpected in the microstructure. No plausible explanation was offered by the vendor.

*Figure 2-18. Side 1 of Vac Hyd VH-9 Coated Sample (Flame Side)*

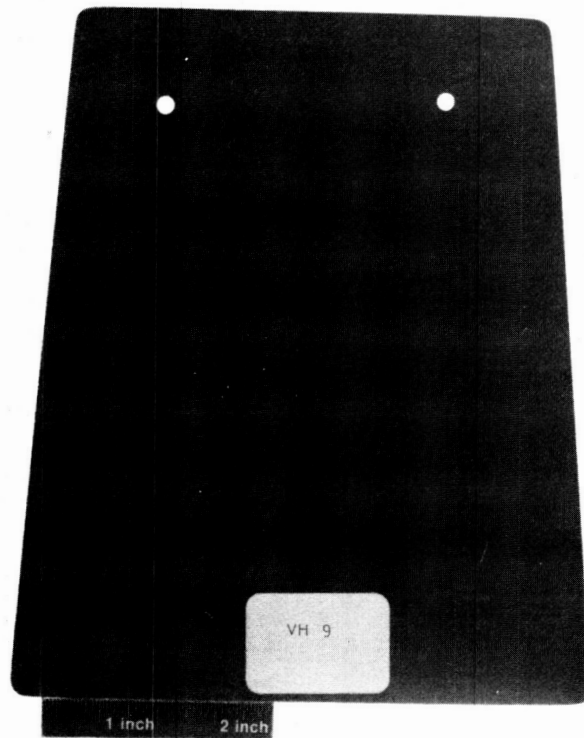
*Figure 2-19. Side 2 of Vac Hyd VH-9 Coated Sample*

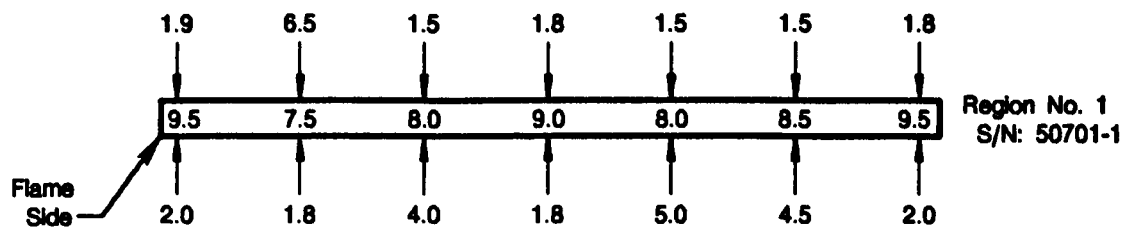
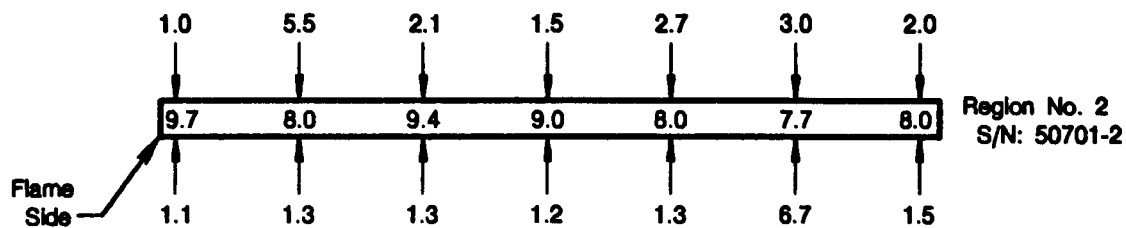
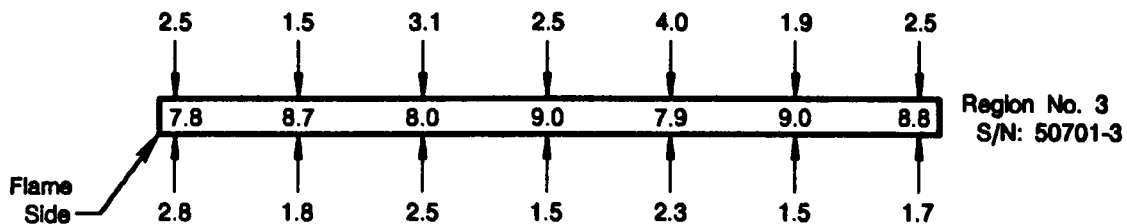
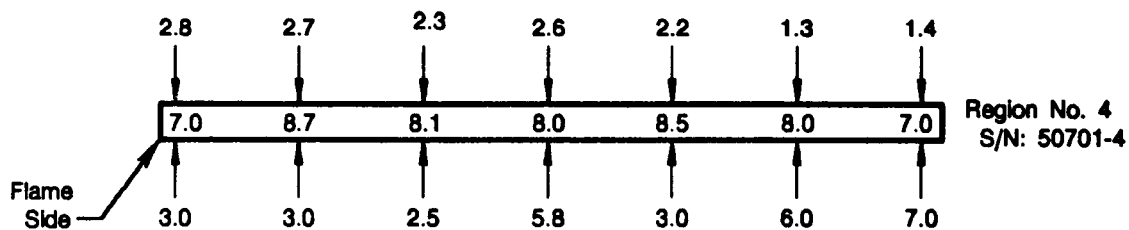
Figure 2-20. Vac Hyd VH-9 Coating and Substrate Thickness Distributions

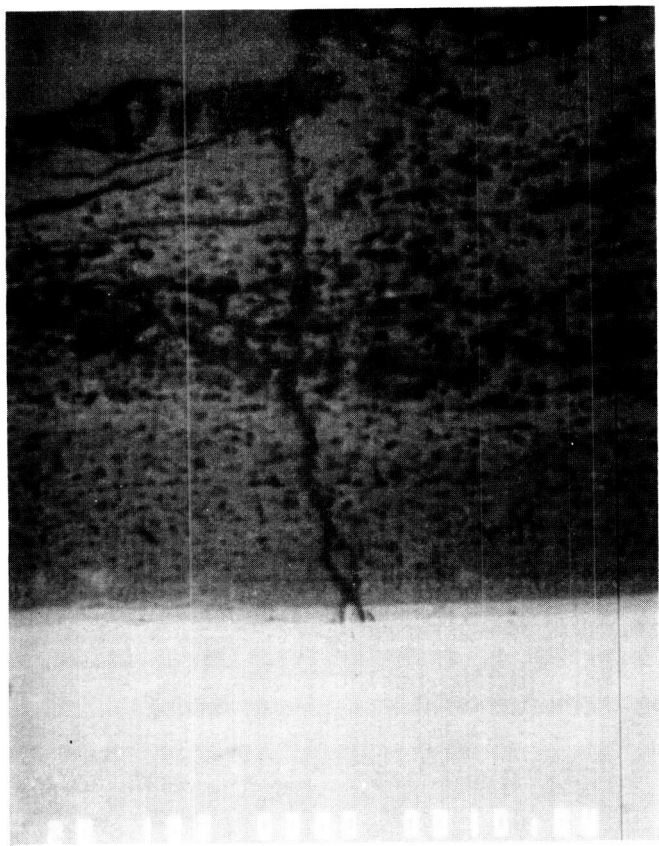
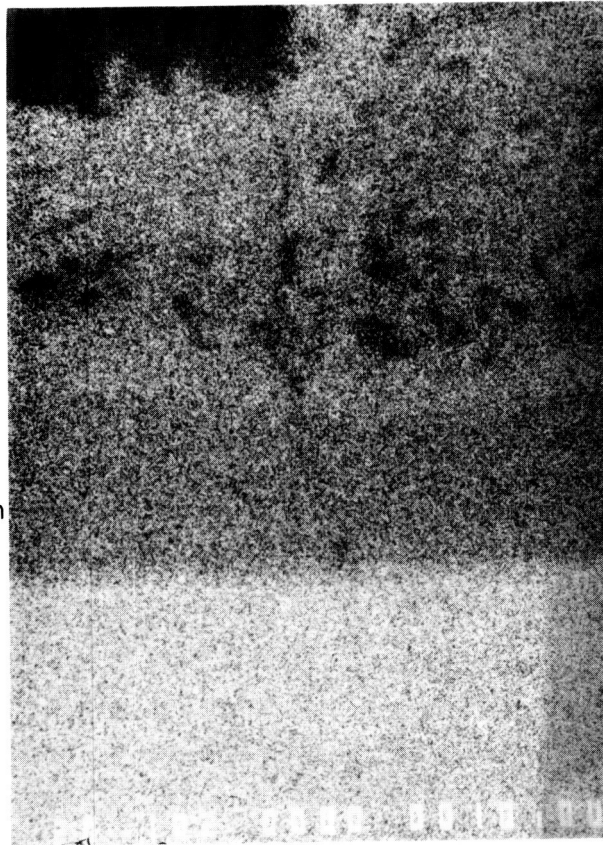
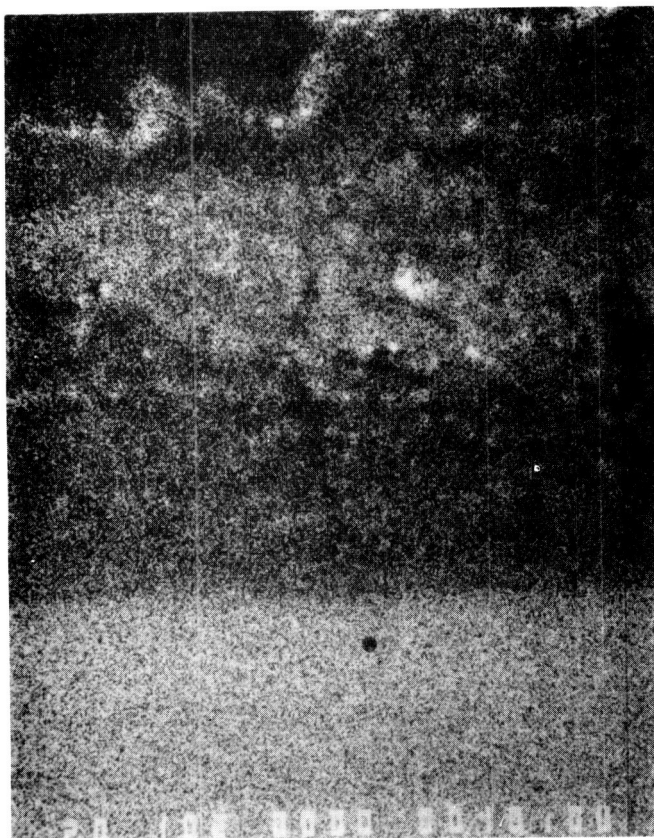
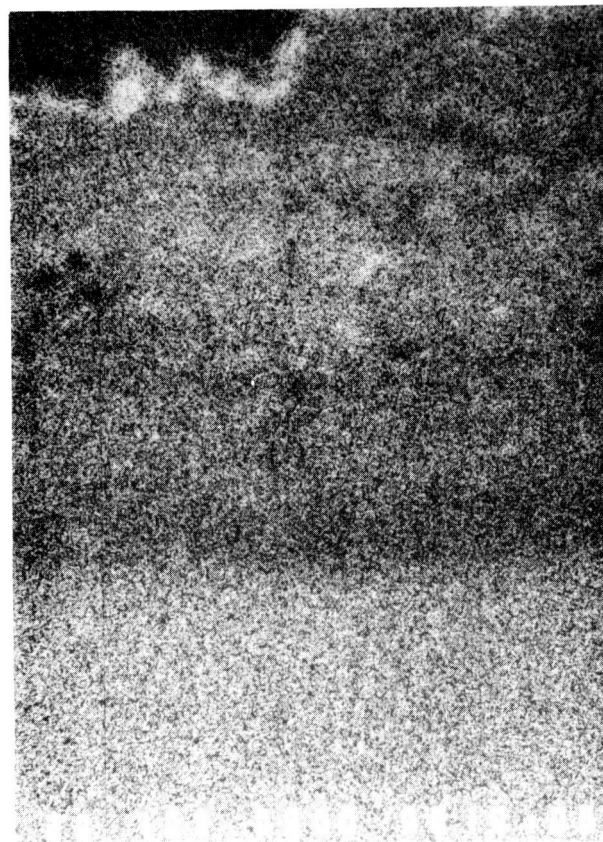
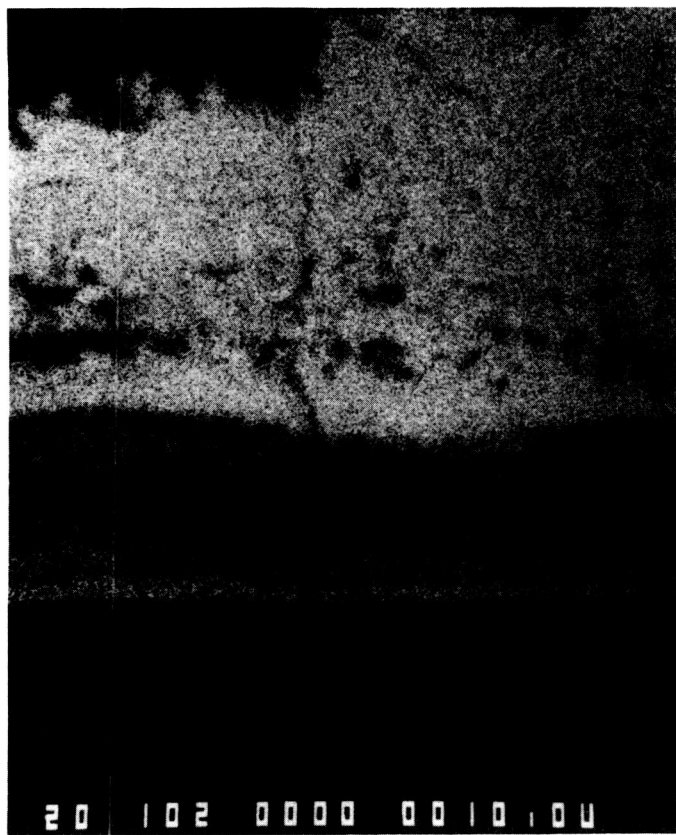
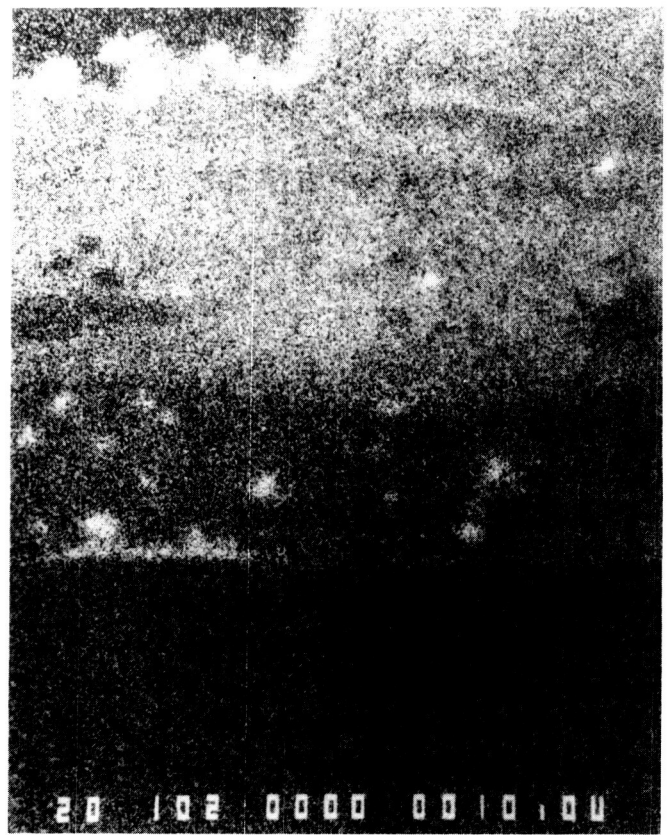
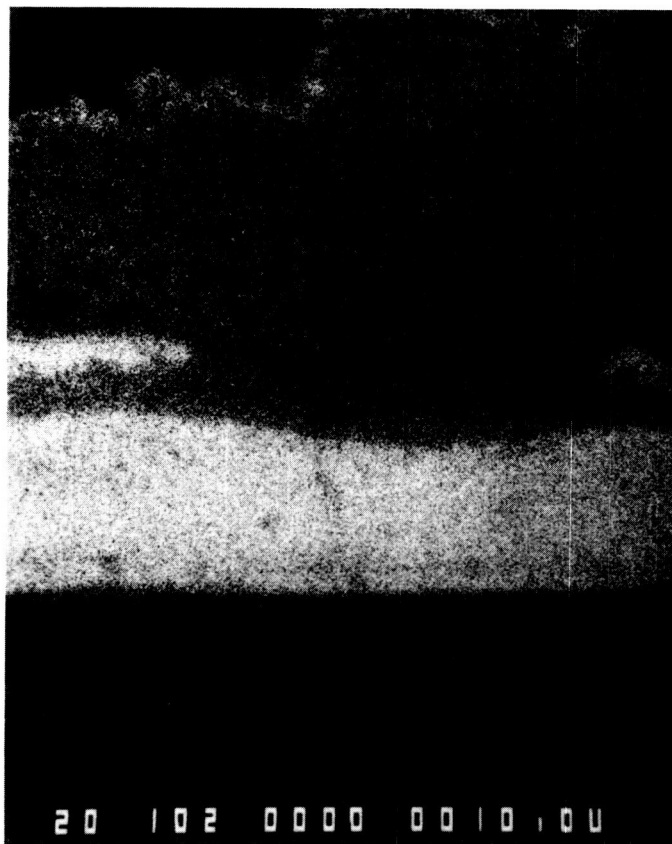
Figure 2-22. Elemental X-ray Maps of Vac Hyd VH-9 (Sheet 1 of 2)

Figure 2-22. Elemental X-ray Maps of Vac Hyd VH-9 (Sheet 2 of 2)

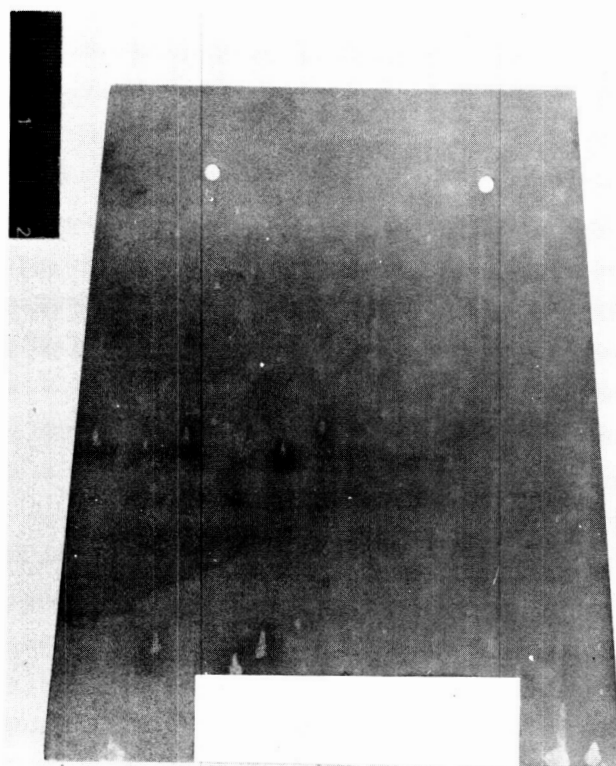
The R505-F coated panel had visual streaks and surface discolorations (Figures 2-23 and 2-24). Coating average thickness was  $3.6 \pm 1.5$  mils. However, Region 4 showed a consistently thicker coating of about 5.0 mils (Figure 2-25). The substrate thickness averaged  $16.2 \pm 0.6$  mils. The typical coating had globular MoAl precipitates in a Sn matrix. A very thin interdiffusion zone was evident. Some regions show extensive voids in the coating. It was unclear whether the voids were entrapped gas or associated with metallographic pull-out. (Figure 2-26). Panel edges had thin coatings and may be problem areas for complete coating coverage. Microprobe results identified the interdiffusion zone as Al rich (Figure 2-27). Cb appeared to have interacted with the MoAl precipitates while Hf and Ti were barely detected in the coating. Sn was the predominant coating matrix material.

*Figure 2-23. Side 1 of Hitemco R505-F (Flame Side)*

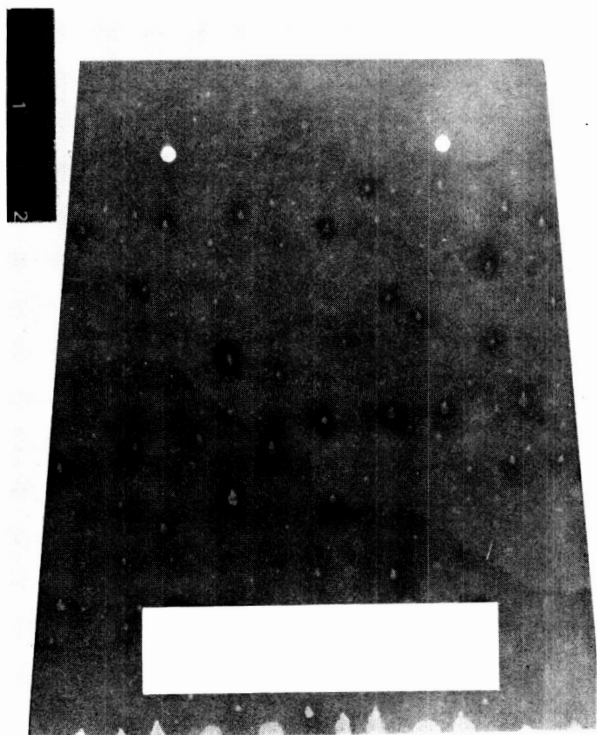
*Figure 2-24. Side 2 of Hitemco R505-F*

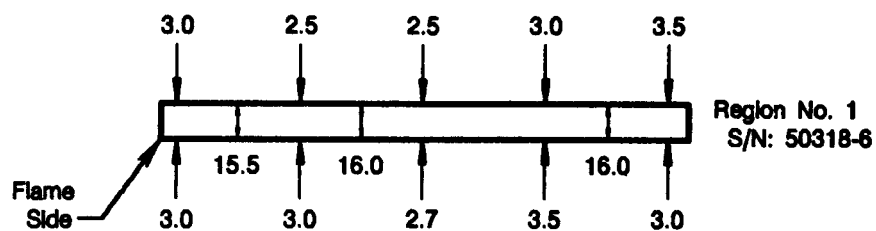
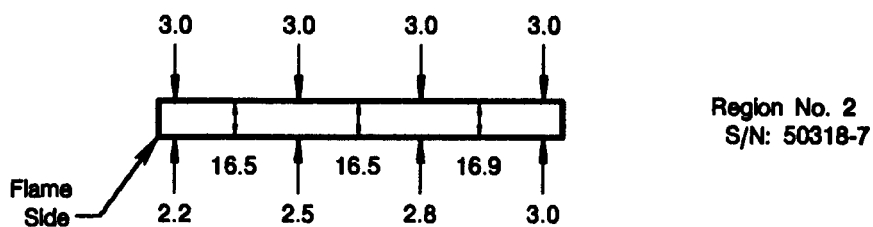
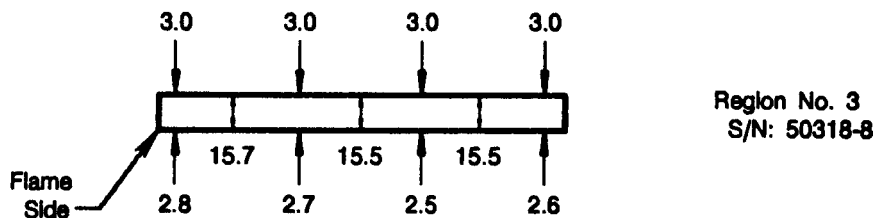
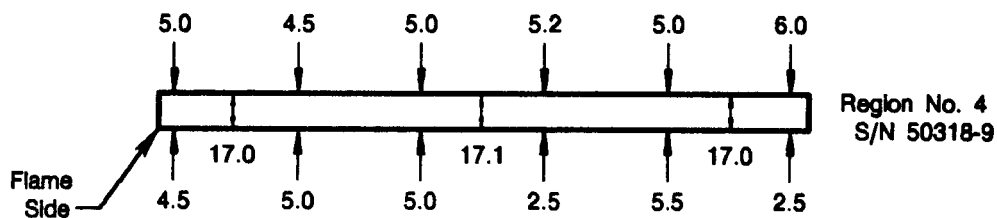
Figure 2-25. Hitemco R505-F Coating and Substrate Thickness Distributions

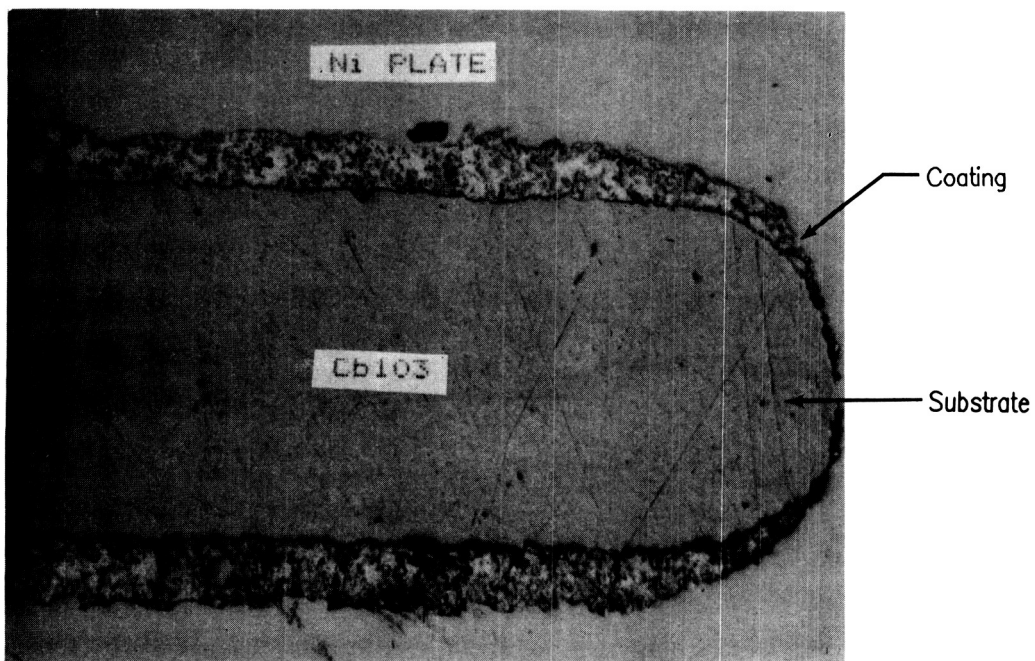
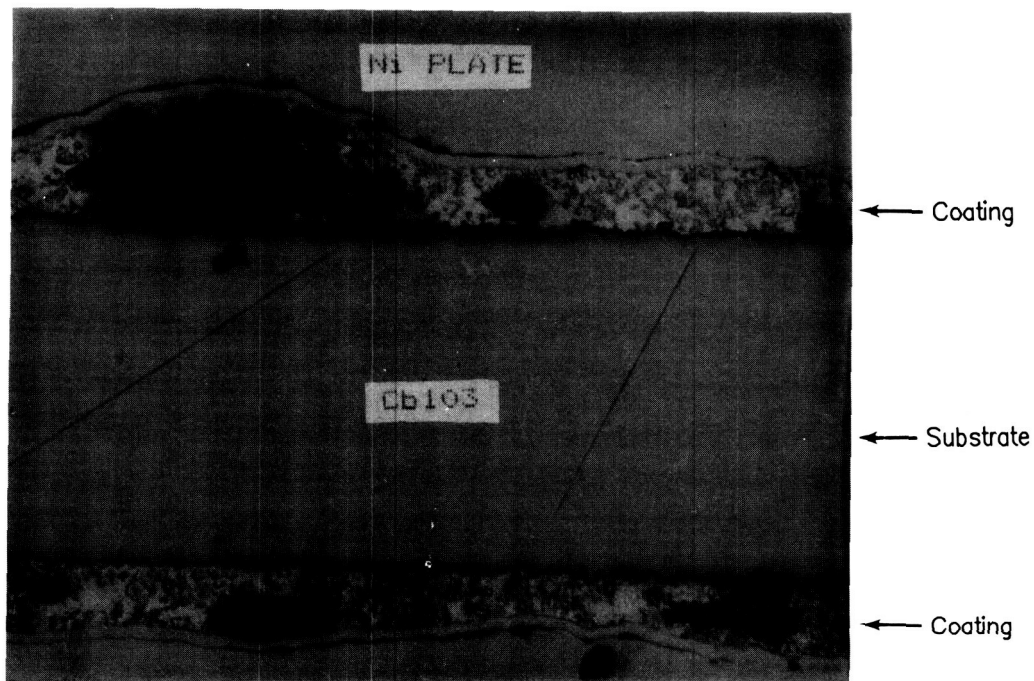
Figure 2-26. Hitemco R505-F Microstructure (Etch: 10% HCL; 90% H<sub>2</sub>O; Thickness  $3.4 \pm 1.0$  mils) (Sheet 1 of 2)

Figure 2-26. Hitemco R505-F Microstructure (Etch: 10% HCL; 90% H<sub>2</sub>O; Thickness  $3.4 \pm 1.0$  mils) (Sheet 2 of 2)

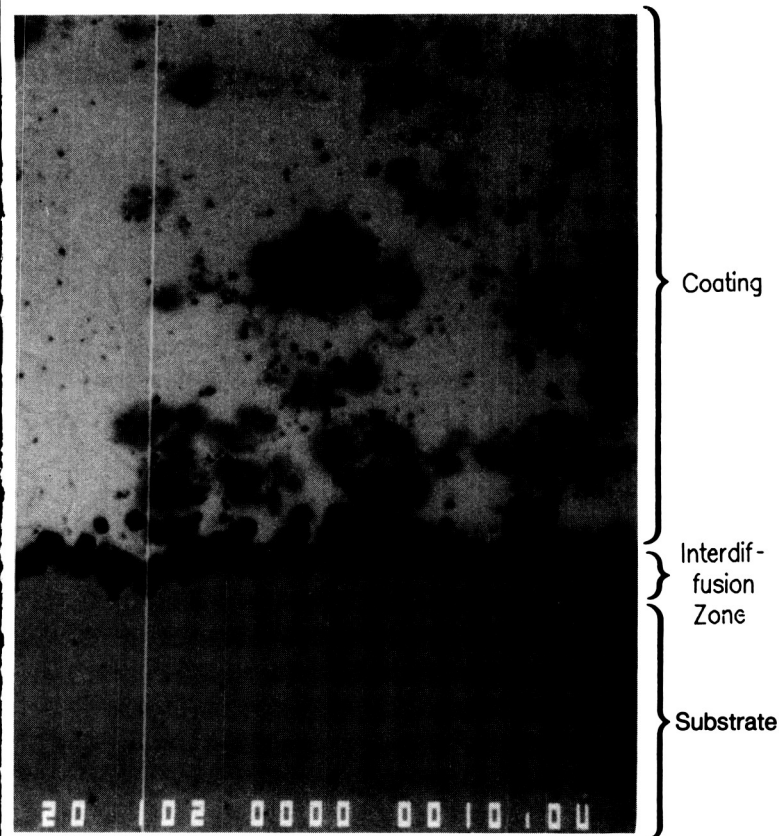
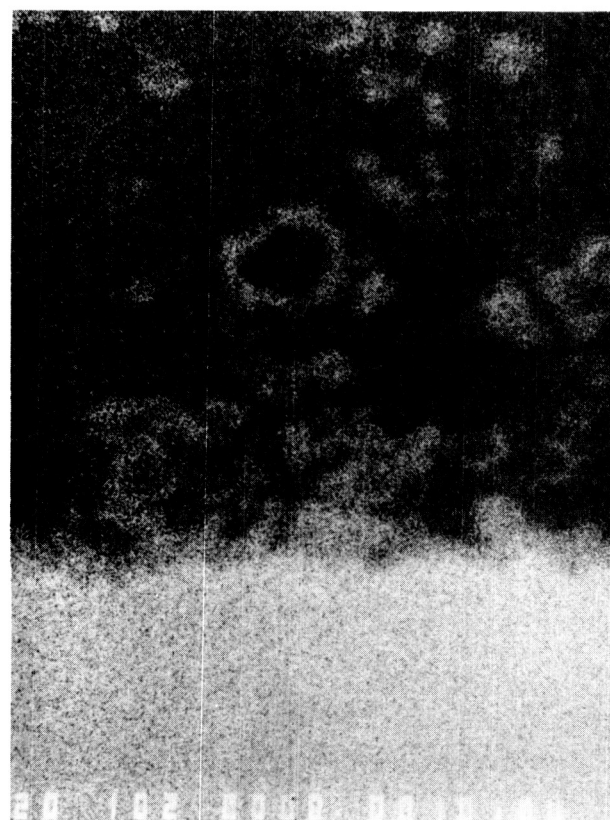
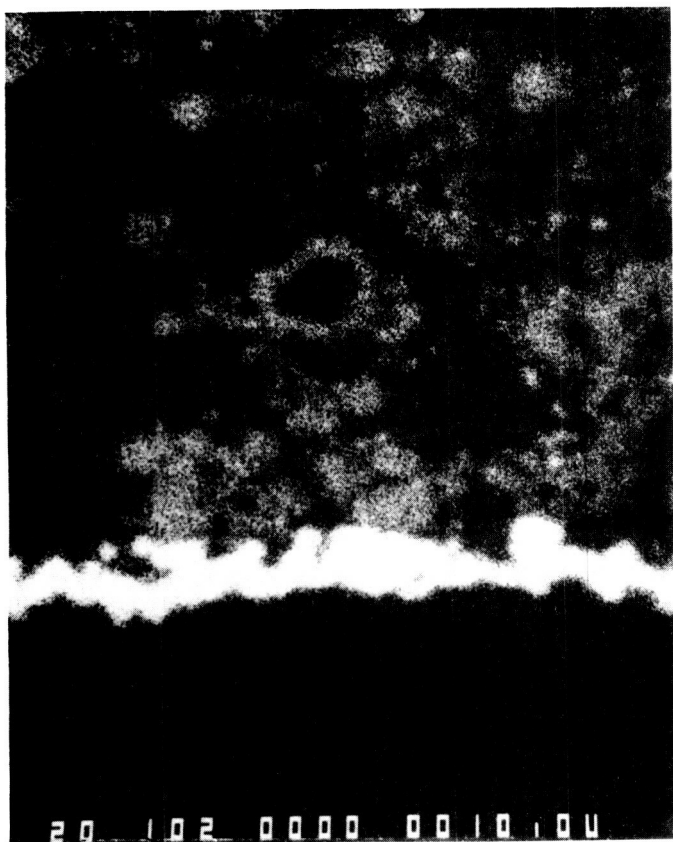
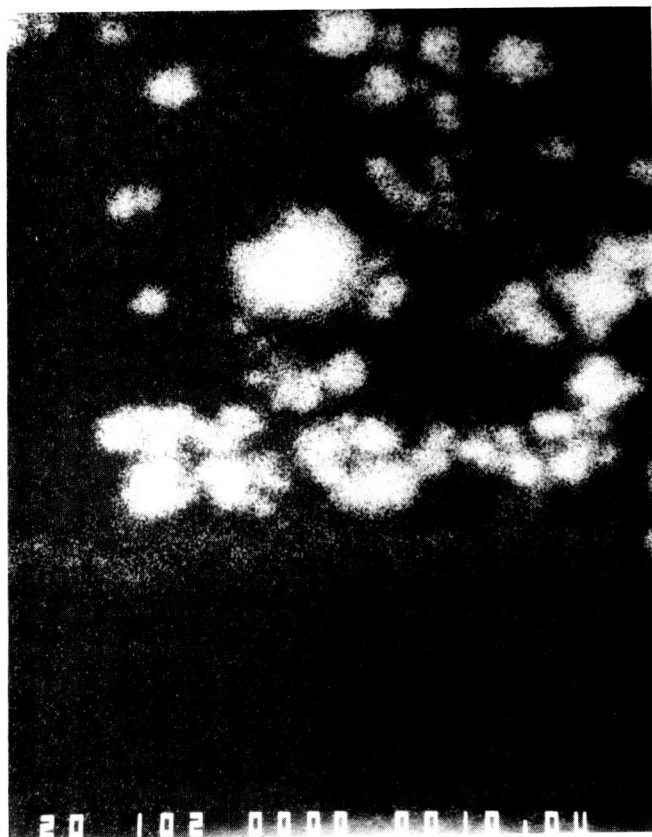
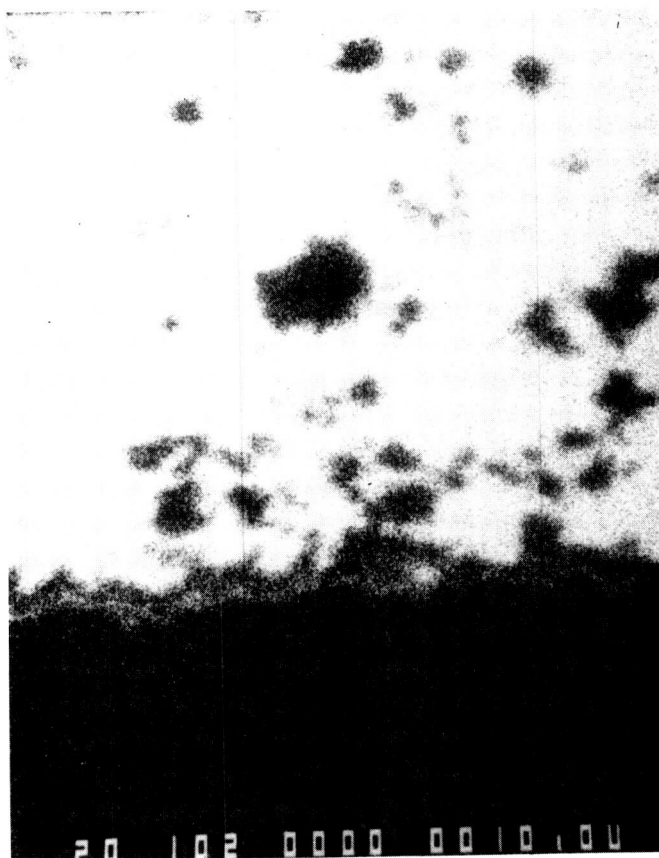
Figure 2-27. Elemental X-ray Maps of Hitemco R505-F (Sheet 1 of 2)

Figure 2-27. Elemental X-ray Maps of Hitemco R505-F (Sheet 2 of 2)

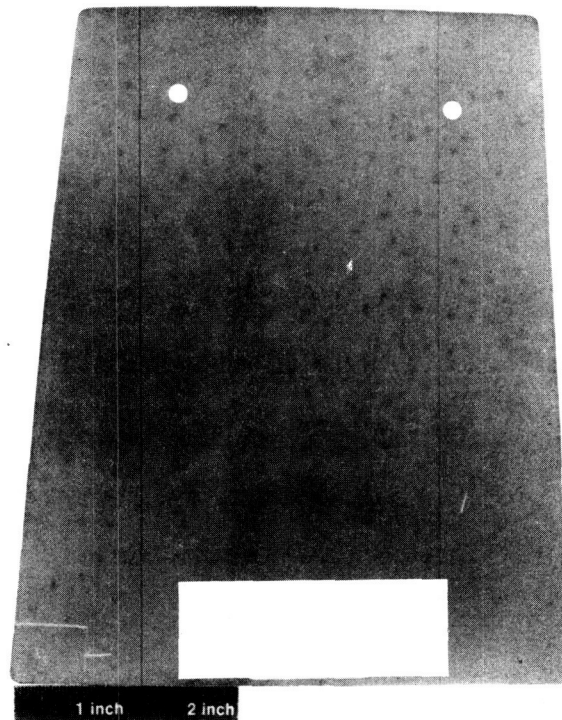
The VH-2 coating had a blue-gray color and was very smooth (Figures 2-28 and 2-29). The coating thickness was greater than requested,  $5.3 \pm 0.8$  mils (Figure 2-30). The substrate was

Figure 2-29. Side 2 of Vac Hyd VH-2 Coating Sample

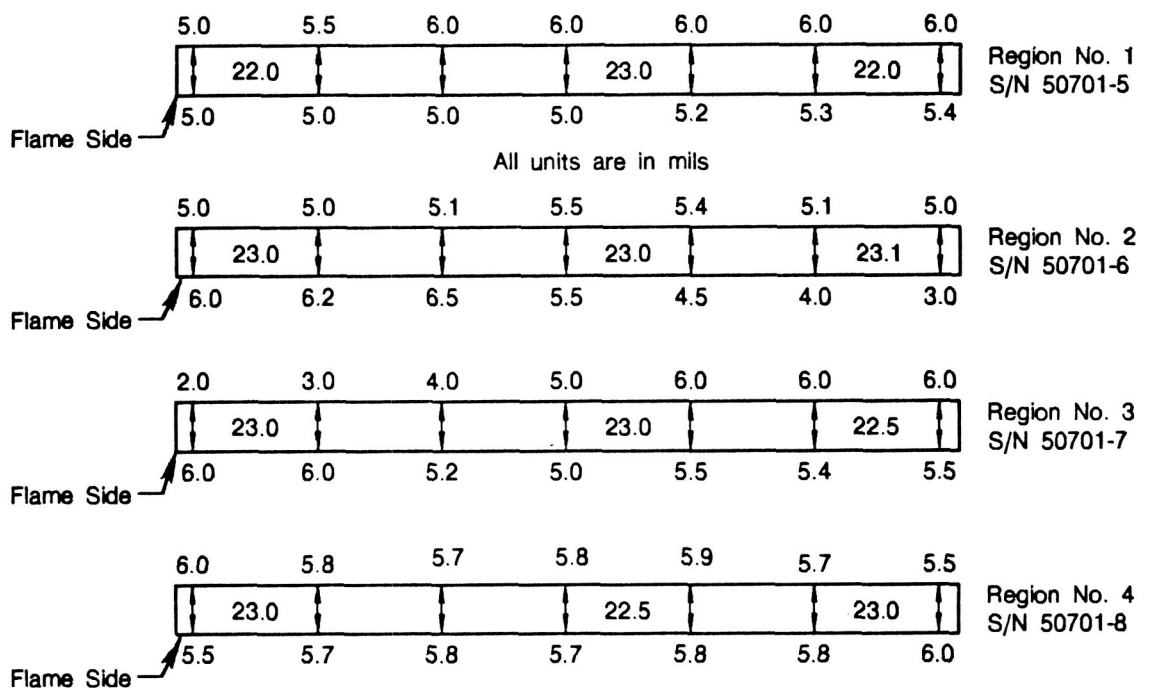
unusually thick, between 22.0 and 23.0 mils. Metallographically, the coating appears to be composed of spherical particles with very little interaction with the substrate (Figure 2-31). The particles were closely packed near the substrate and loosely held together near the external surface. Small voids in the coating about 0.6 mil above the coating/substrate interface evolved during metallographic polishing. Edge corners had unusual coating coverage. The coating did not cover corners uniformly and continuously. The microprobe detected only Al in the coating and discussions with Vac-Hyd confirmed the VH-2 composition as consisting essentially of Al (Figure 2-32).

Figure 2-30. Vac Hyd VH-2 Coating and Substrate Thickness Distributions
